Dam ID: OA-0045
HELEMANO 16 RESERVOIR

Inspection No: _____
Date: 3 April 2006

**STATE OF HAWAII - DLNR
 DAM SAFETY INSPECTION SHEET**

Inspection Type: Visual Dam Safety Inspection

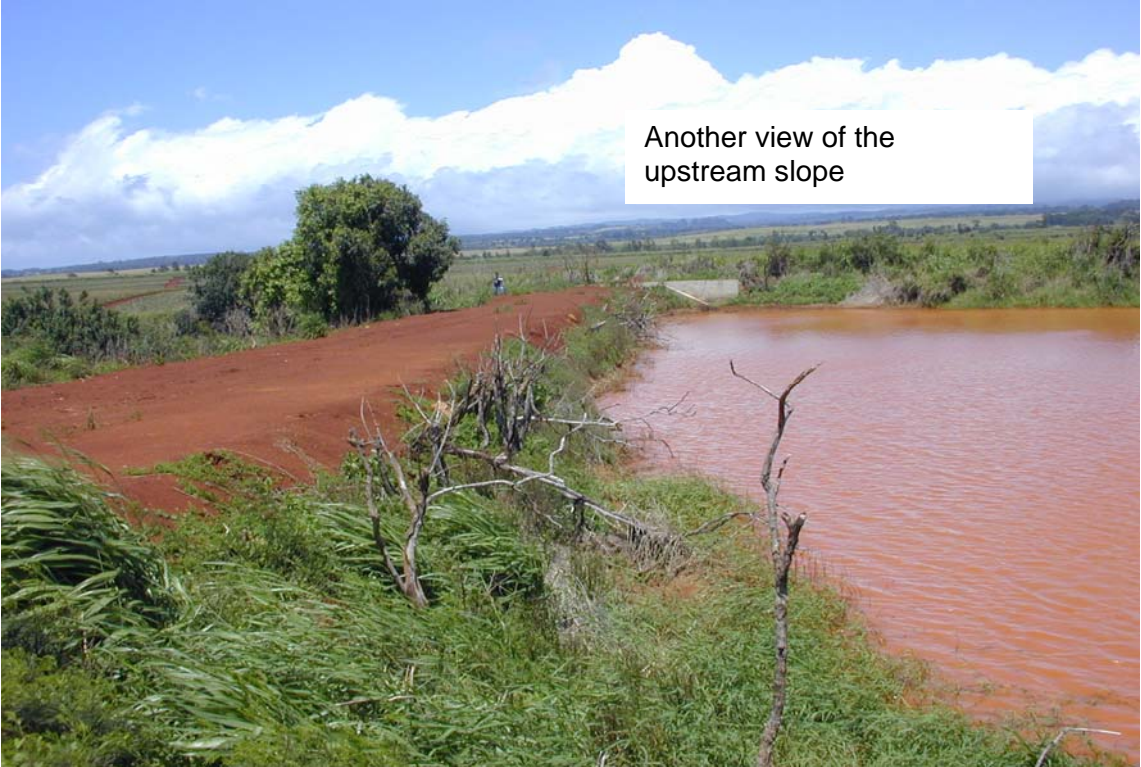
Another view of the upstream slope

- j. Tree(s) were observed on the dam embankment. Trees have been identified as the probably cause of piping failures, and can possibly cause sever damage to the embankment if they are uprooted during a high winds. Corrective action is required to remove the tree hazards from the dam. Acceptable remedies include removal of the tree and its root structure down to a 2" diameter and reconstructing the damaged embankment section. All repair work shall be accomplished as per the requirements of licensed geotechnical or structural engineer. Routinely monitor the damaged area for signs of settlement and seepage.

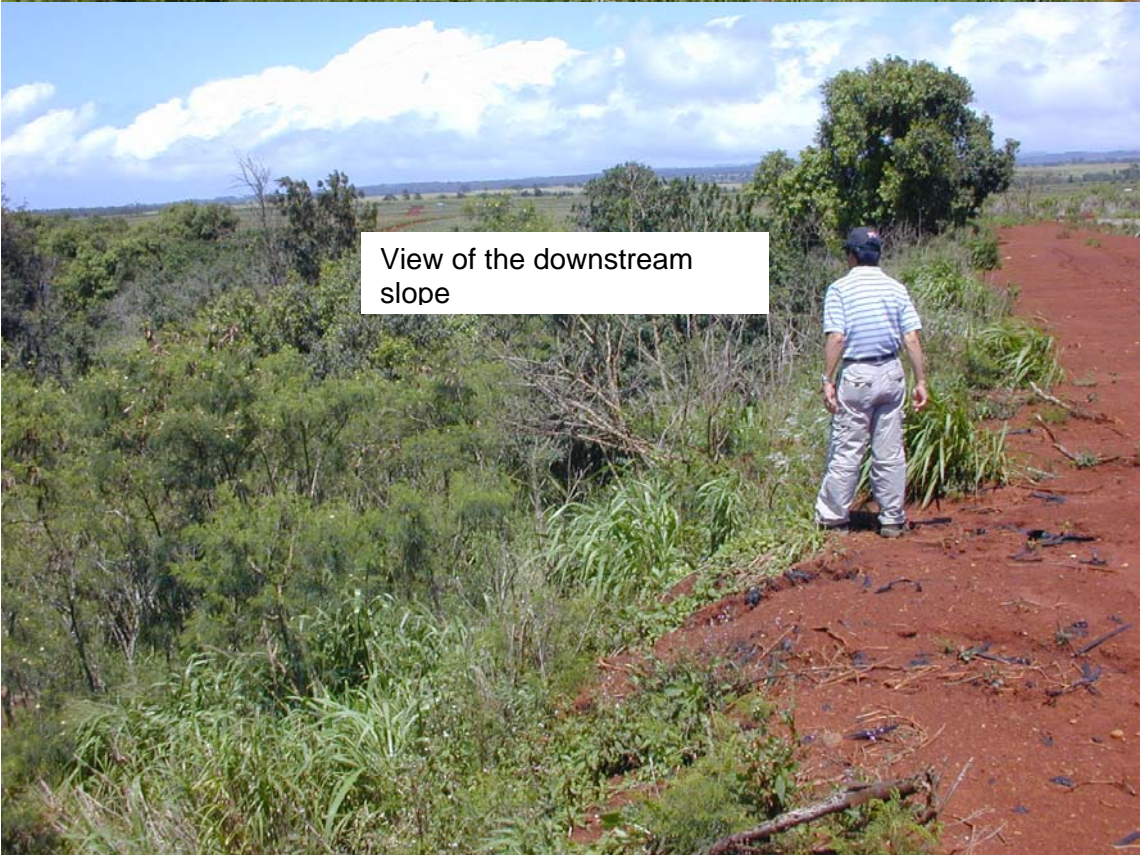
View of the downstream slope

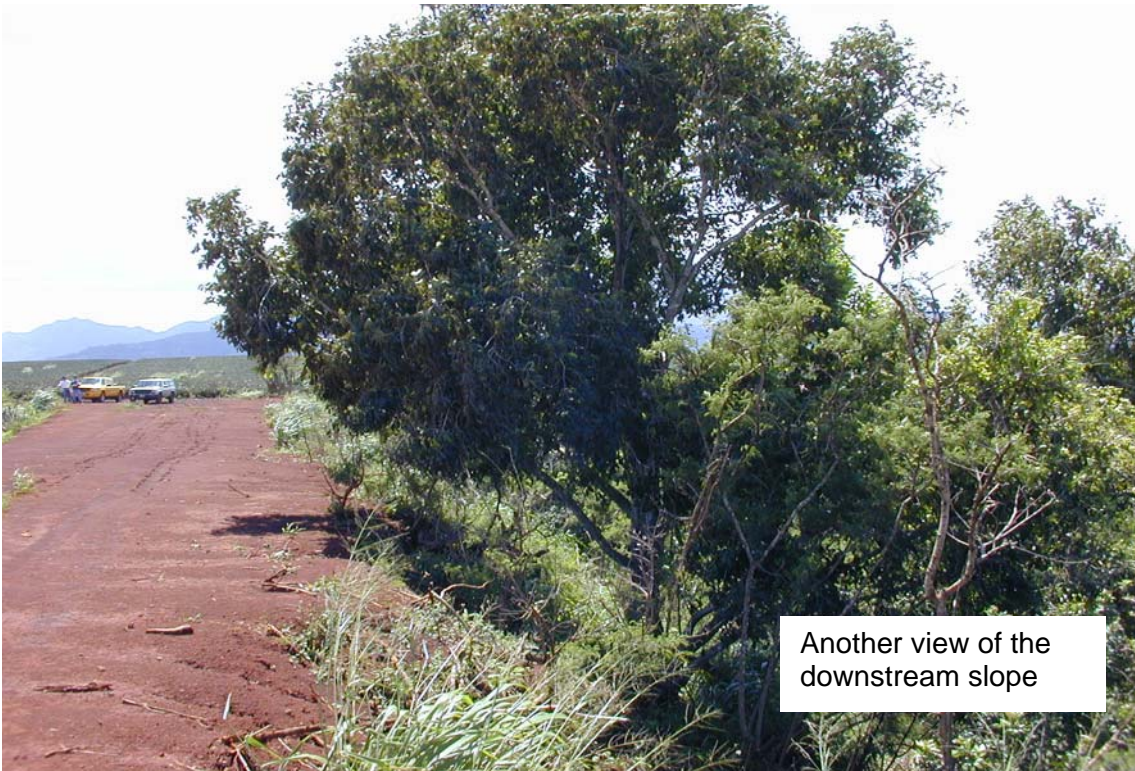
Another view of the downstream slope

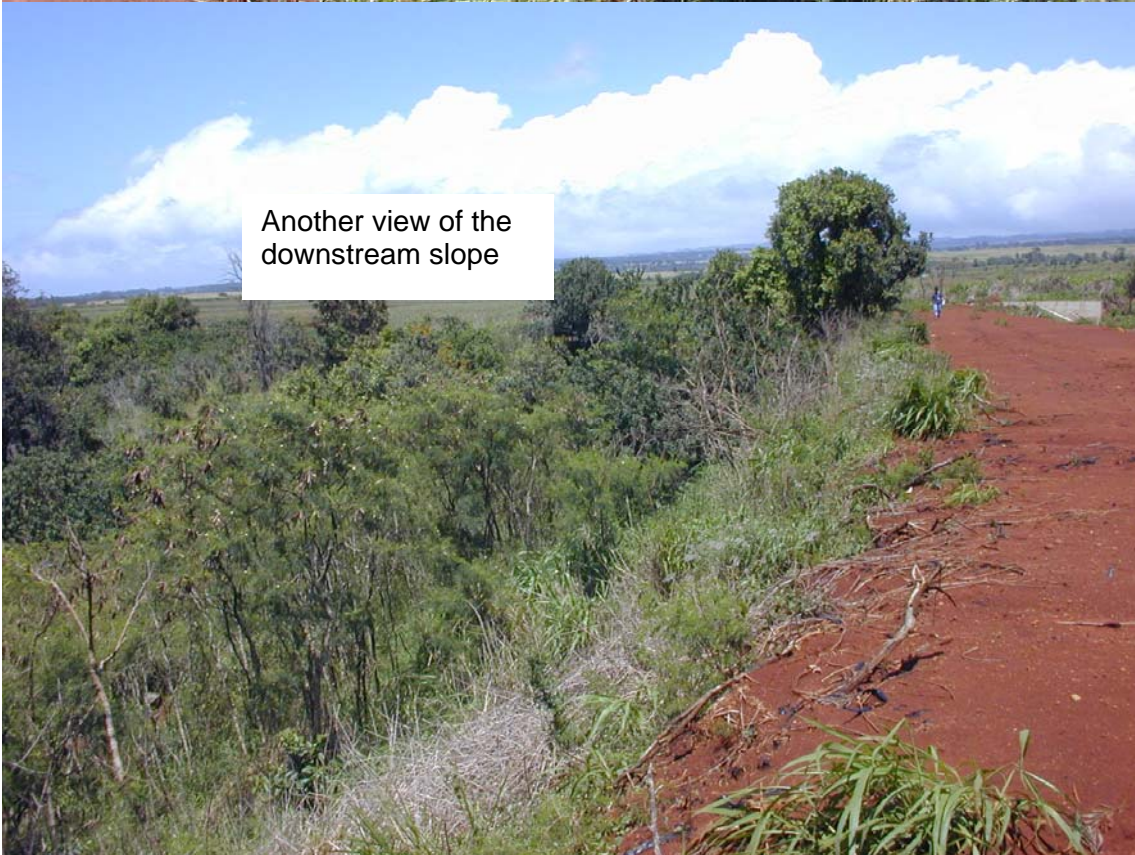
Another view of the downstream slope

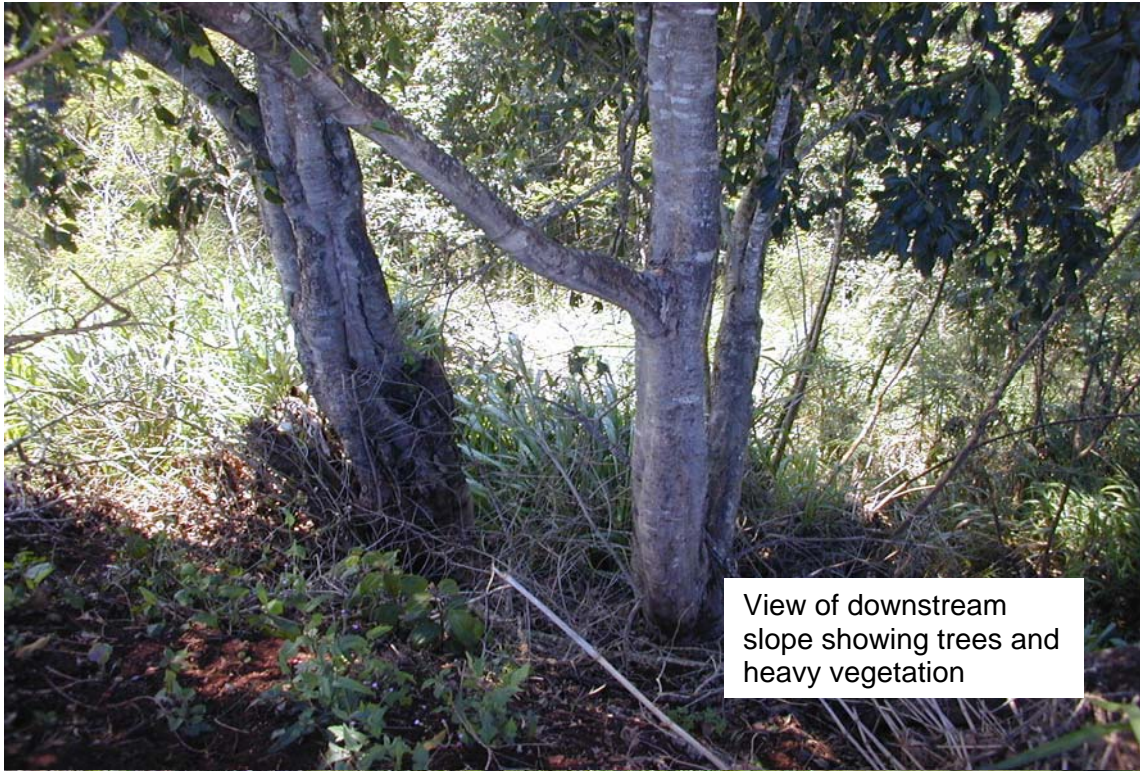
Description: Numerous Hole Koa 2" diameter trunk size

- j. The slope was very steep, around a 1 to 1 slope, further study is required to verify slope stability. 4/2/06
- k. _____

View of downstream slope showing trees and heavy vegetation

- g. Tree(s) were observed on the downstream slope. Trees have been identified as the probably cause of piping failures, and can possibly cause sever damage to the embankment if they are uprooted during a high winds. Corrective action is required to remove the tree hazards from the dam. Acceptable remedies include removal of the tree and its root structure down to a 2" diameter and reconstructing the damaged embankment section. All repair work shall be accomplished as per the requirements of licensed geotechnical or structural engineer. Routinely monitor the damaged area for signs of settlement and seepage. 4/2/06

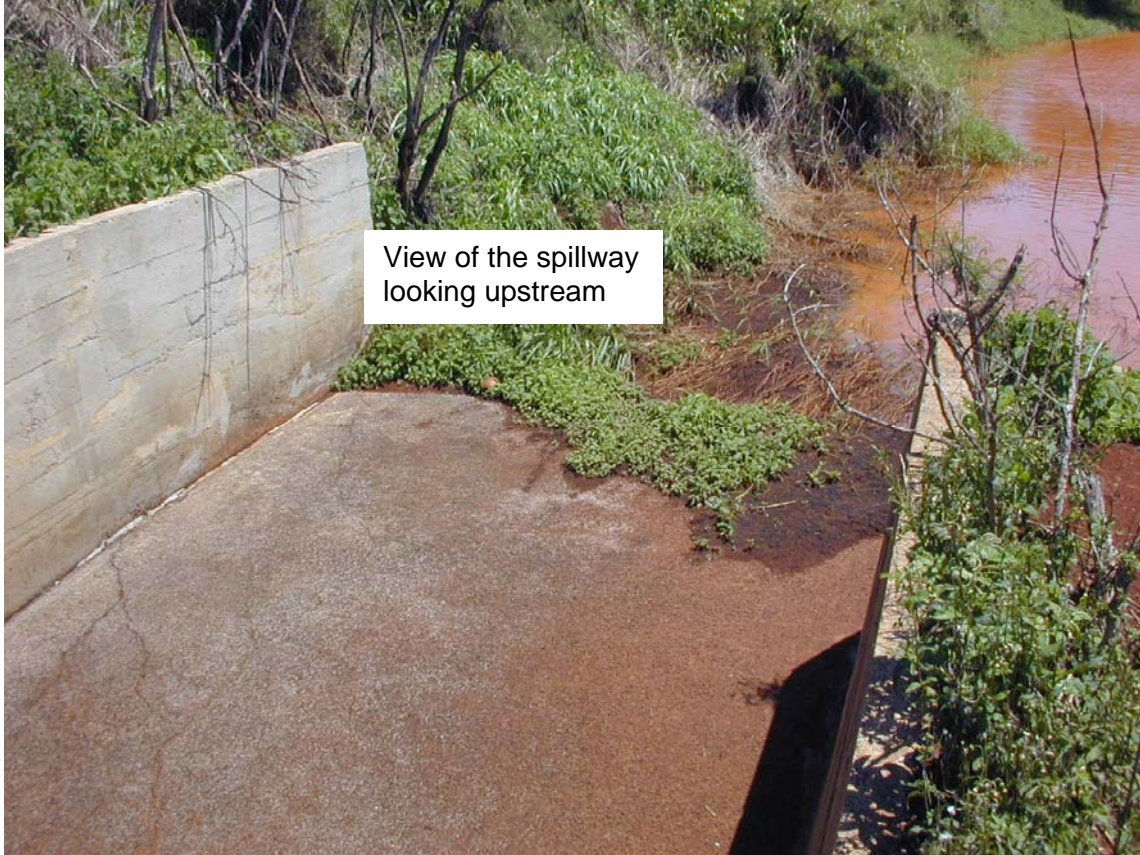
View of the spillway looking upstream

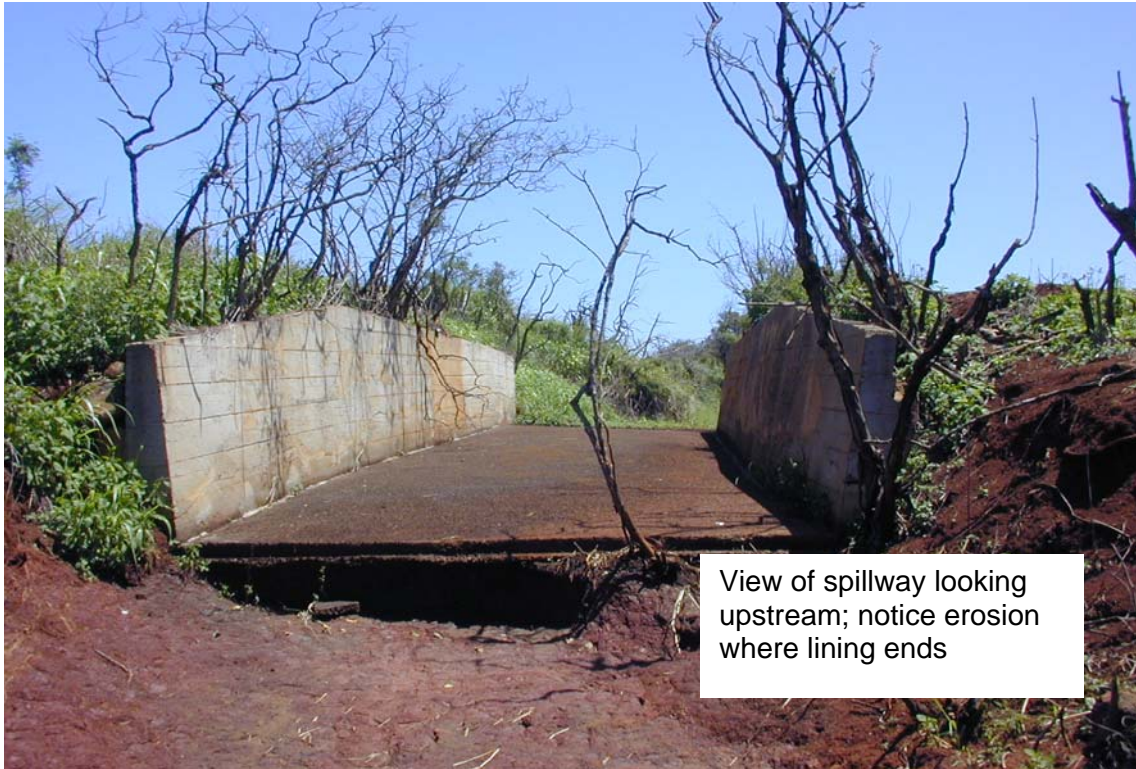
View of spillway looking upstream; notice erosion where lining ends

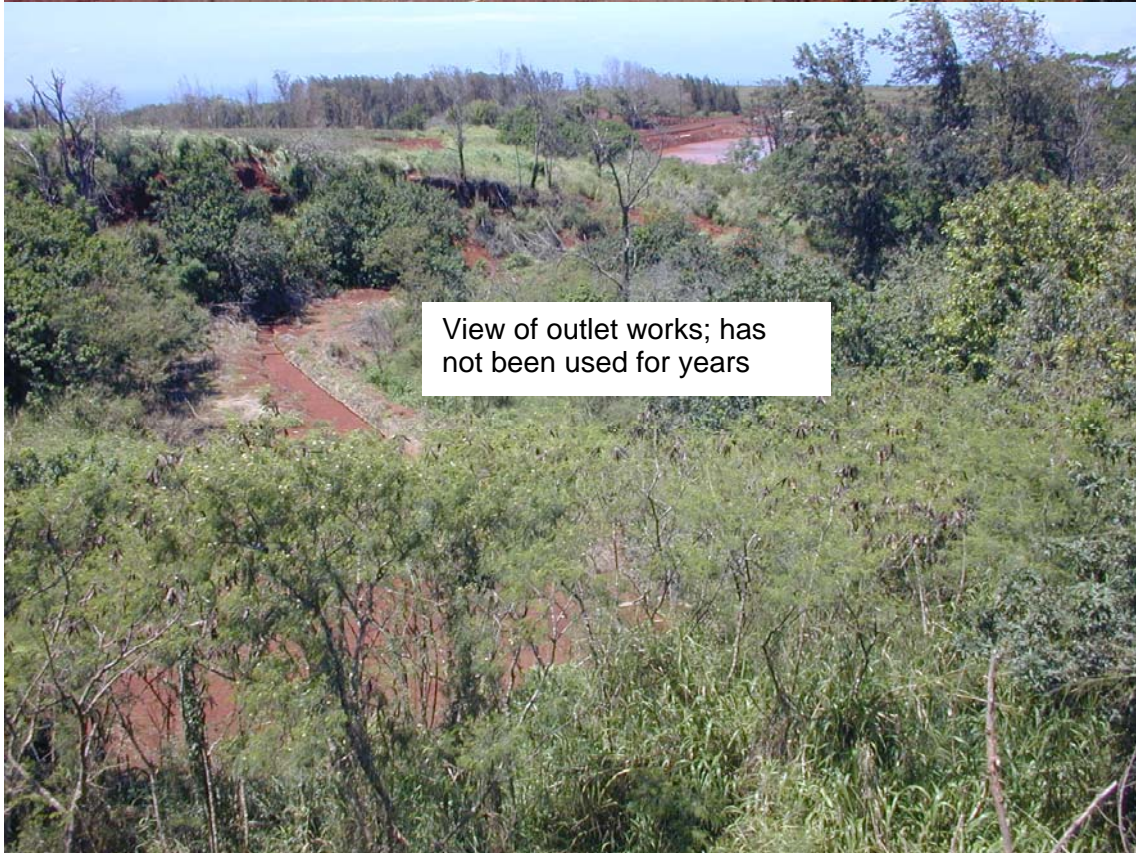
View of outlet works; has not been used for years
