Dam ID: OA-137
OAHU RESERVOIR NO. 155

Inspection No: _____
Date: 4 Apr. 2006

STATE OF HAWAII - DLNR
DAM SAFETY INSPECTION SHEET

Inspection Type: Visual Dam Safety Inspection

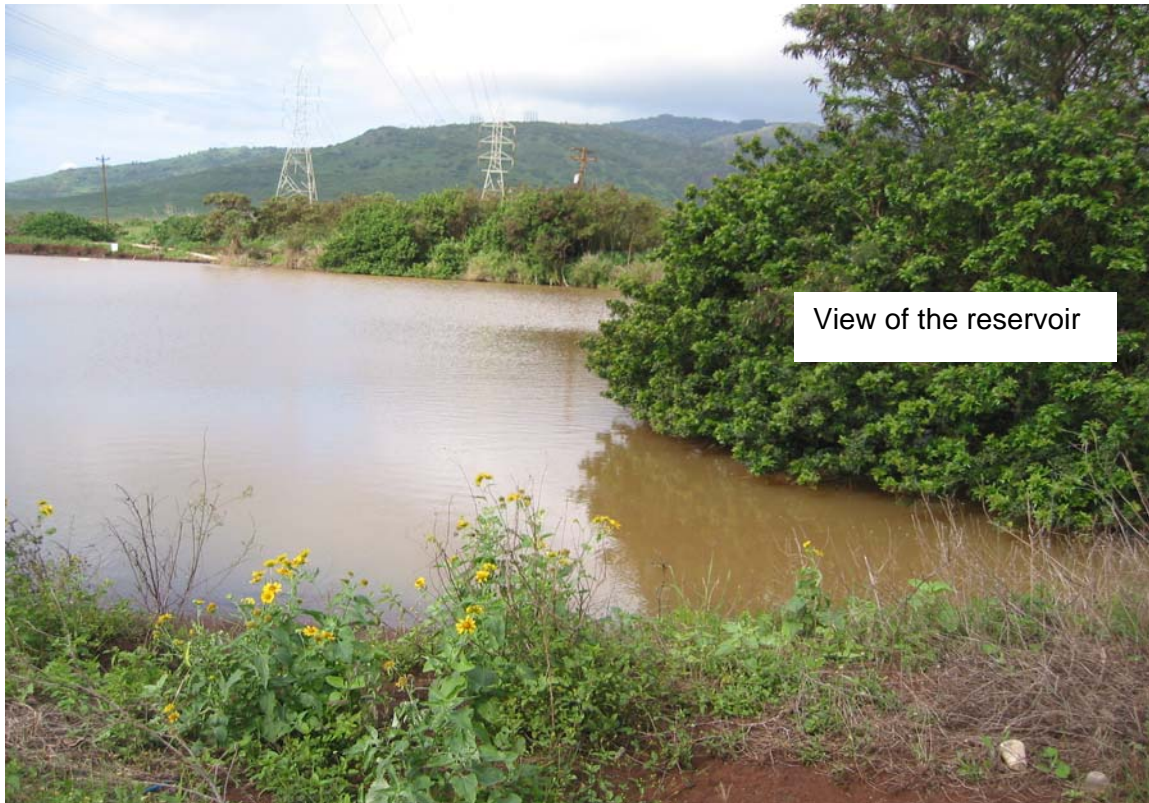
View of the reservoir

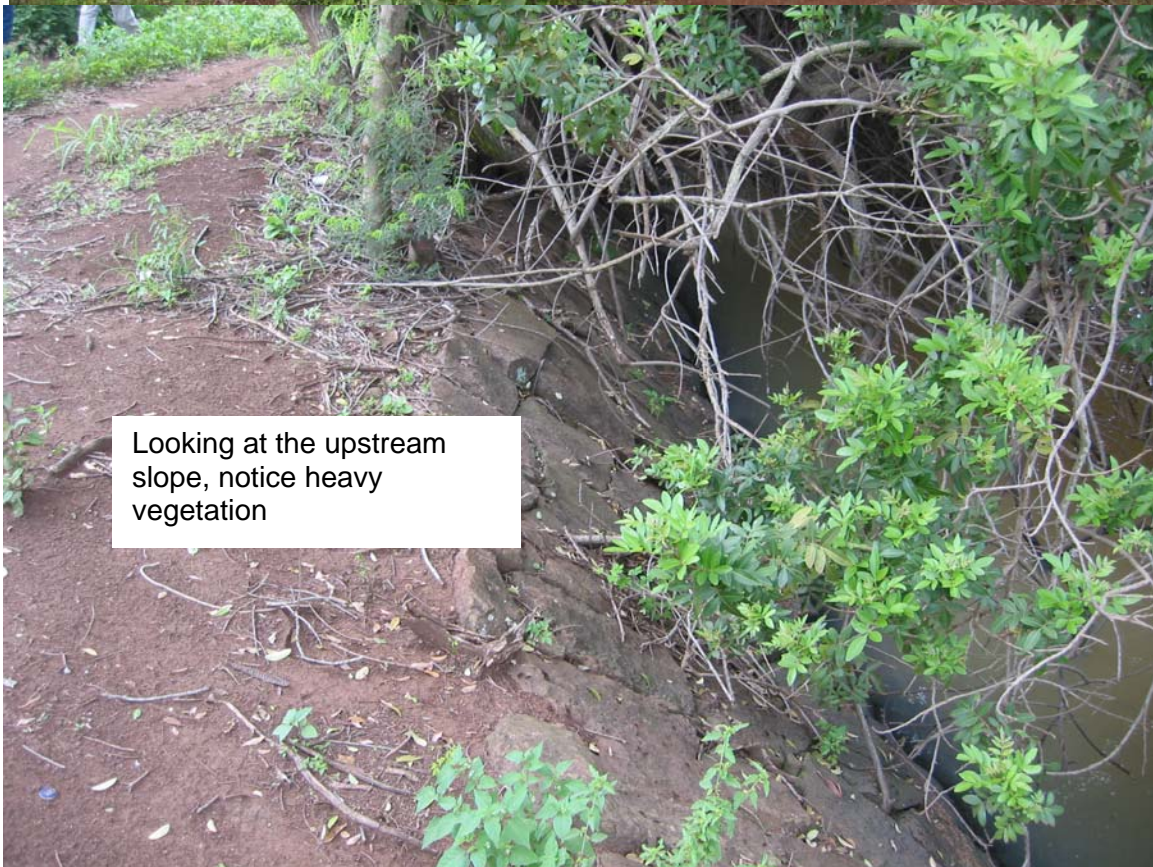
Looking at the upstream slope, notice heavy vegetation

- h. A sinkhole was observed on the slope, which requires further investigation to determine the underlining cause. Repair and monitor the area.
- i. The upstream slope was not visible due to high grass and bush vegetation. Clear high vegetation and maintain low to enable easy visual inspection.

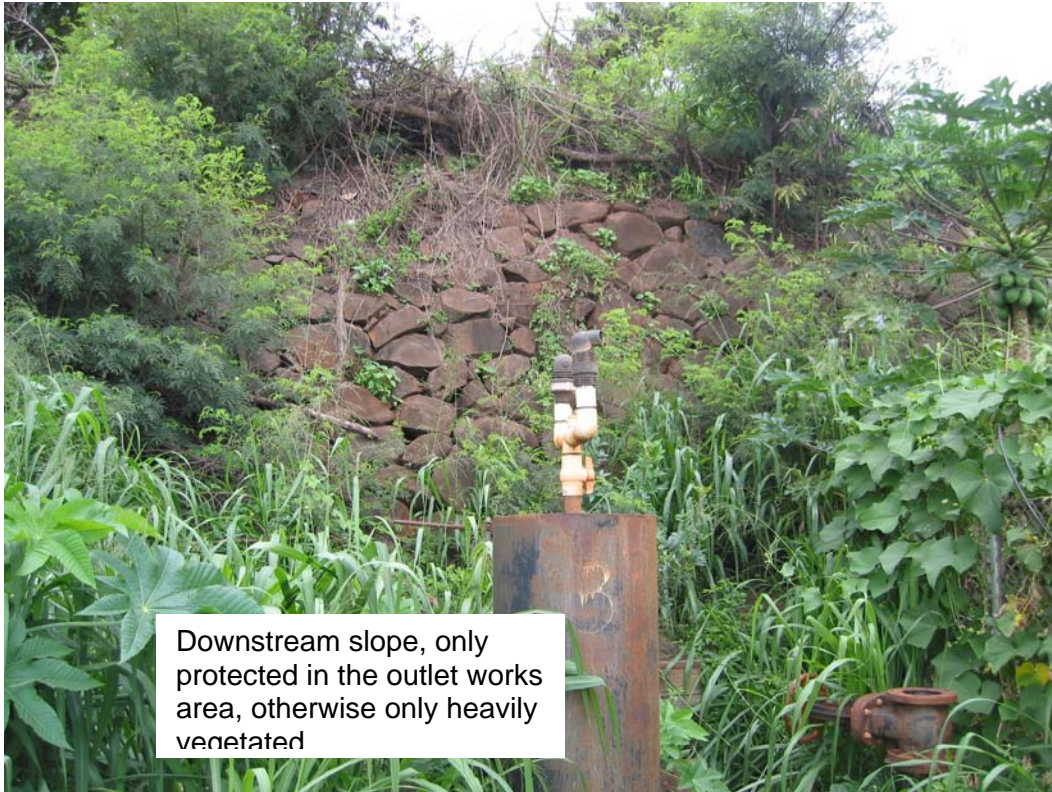
Downstream slope, only protected in the outlet works area, otherwise only heavily vegetated

- h. A sinkhole was observed on the slope, which requires further investigation to determine the underlining cause. Repair and monitor the area.
- i. The down stream slope was not visible due to high grass and bush vegetation. Clear high vegetation and maintain low to enable easy visual inspection.

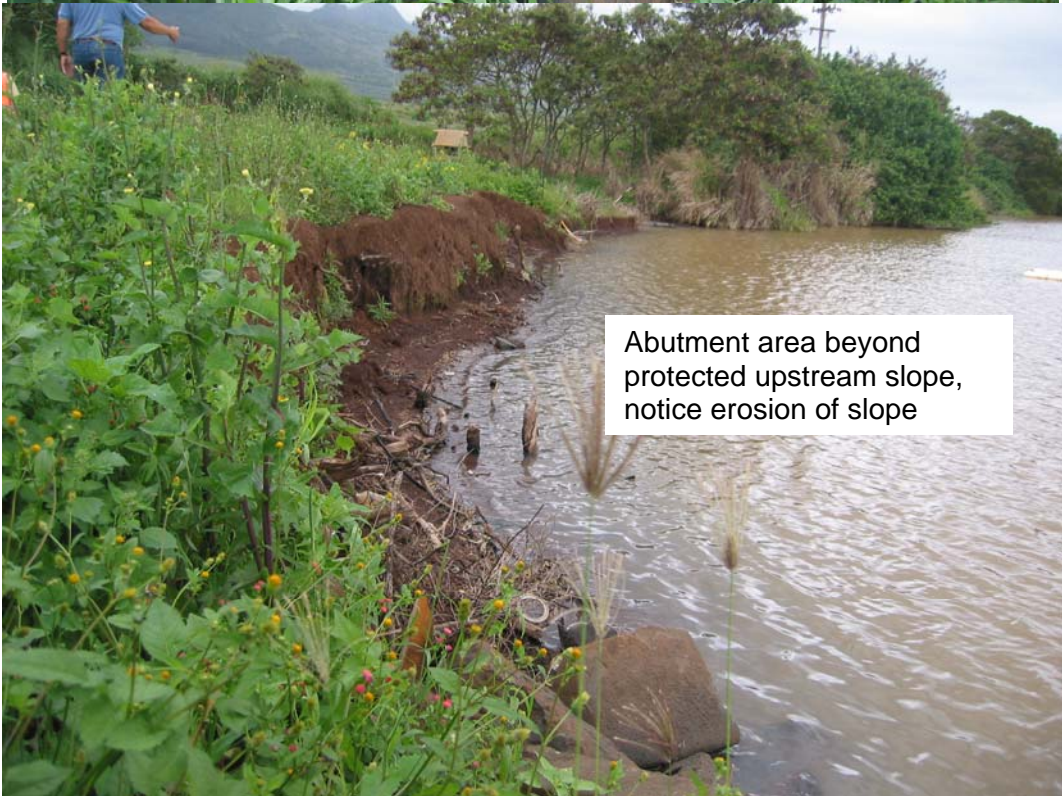
- e. Slope protection needs maintenance or repair. Description: _____
- f. Rut and/or Gully erosion was observed, which requires maintenance and/or repair.
Description: vertical eroded cut

Abutment area beyond protected upstream slope, notice erosion of slope

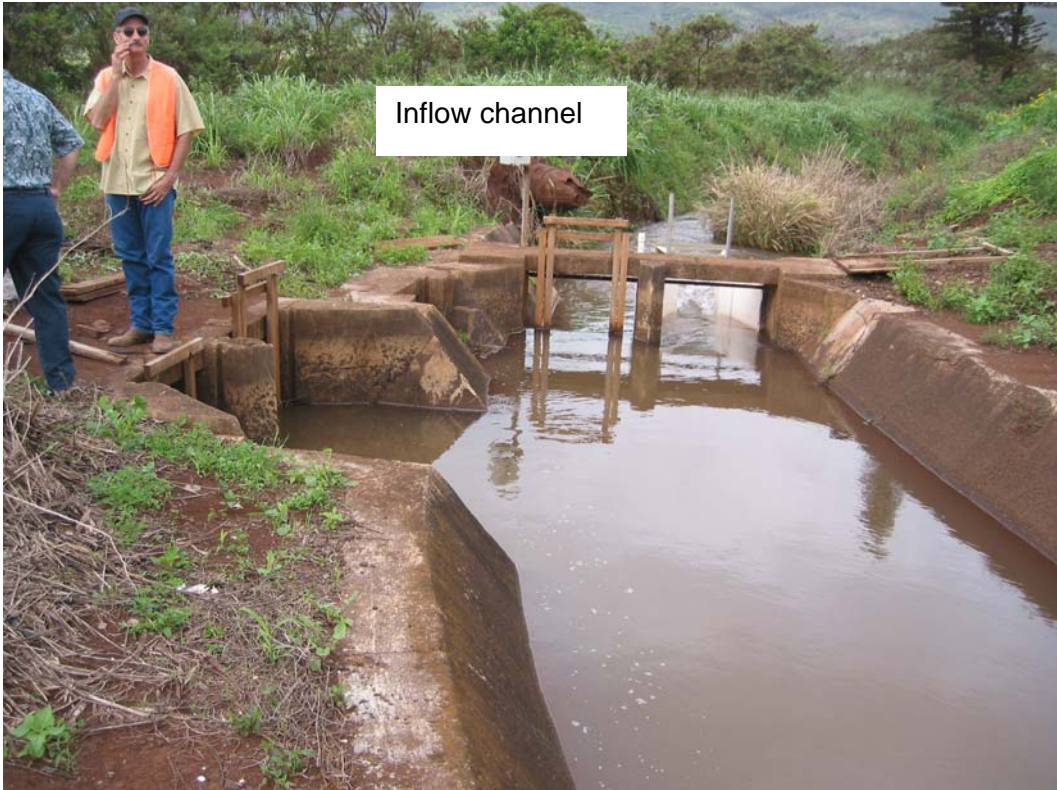
Inflow channel

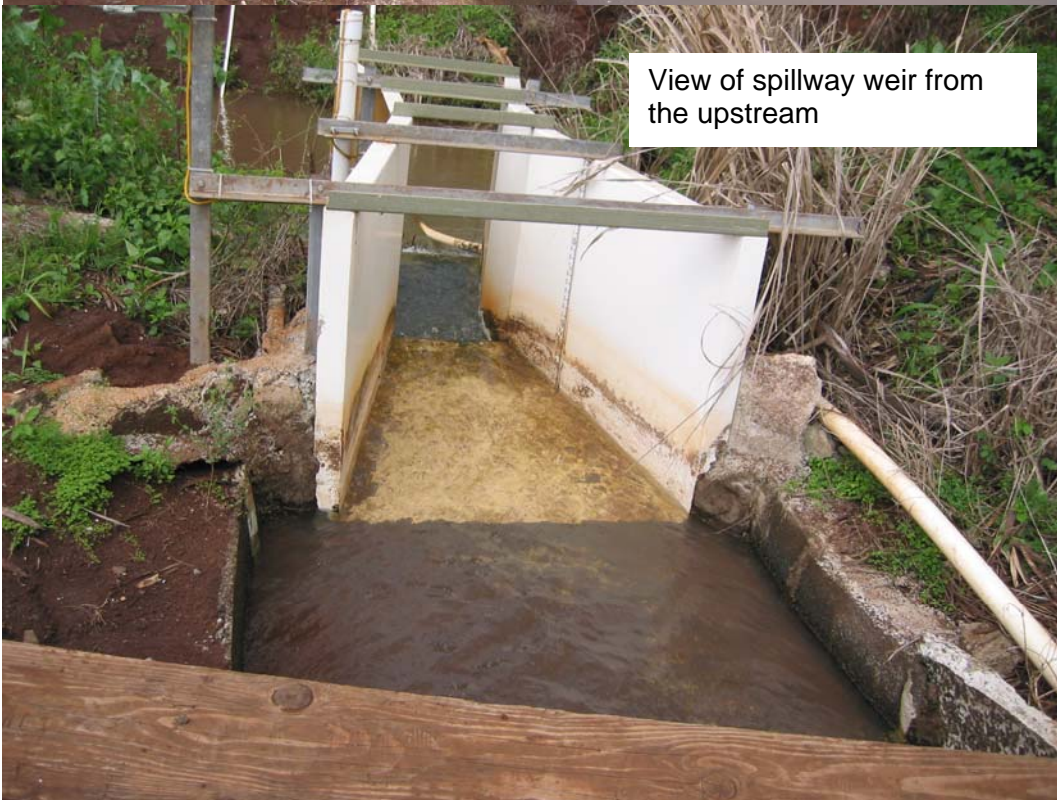
View of spillway weir from the upstream

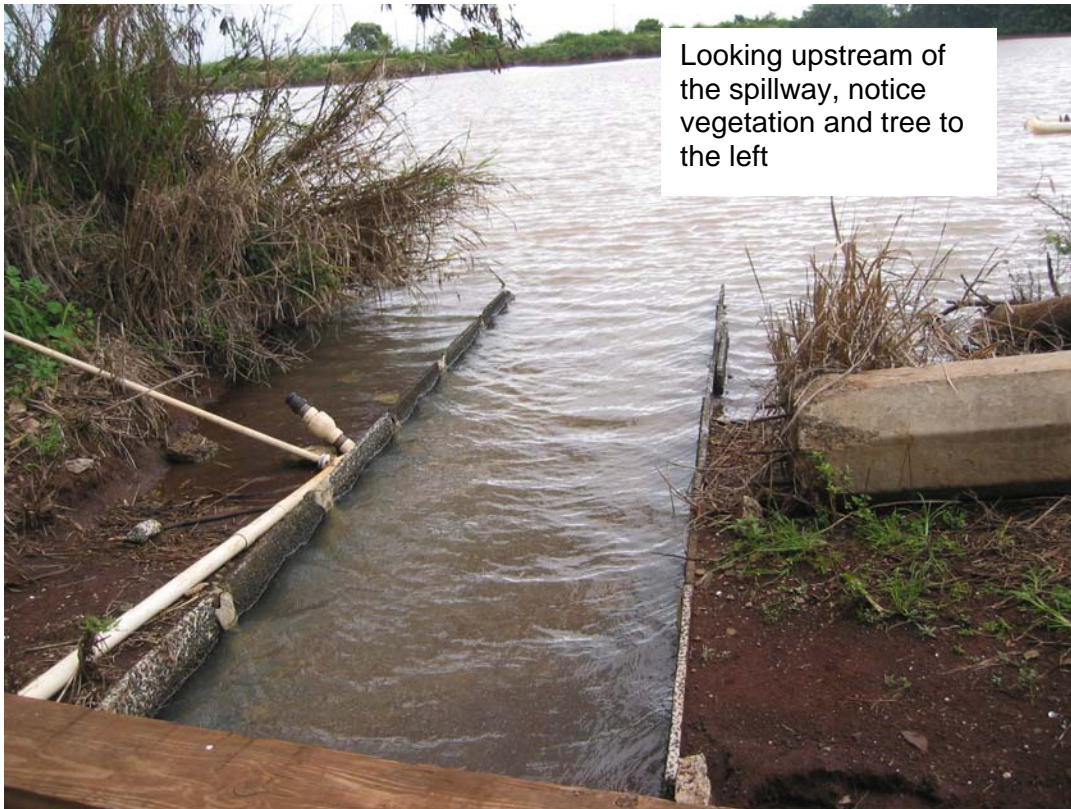
Looking upstream of the spillway, notice vegetation and tree to the left

- d. Slope protection needs maintenance or repair. Description: _____
- e. The spillway approach was blocked. Clear approach.
- f. Severe scour erosion was observed which requires maintenance and/or repair.
Description: _____
- g. A headcut (vertical drop in channel due to erosion) was observed downstream of the spillway. Corrective action is required to prevent this problem from moving upstream.
- h. Trees are unacceptable in the spillway channel and approach. Take corrective action to address the woody vegetation problem and repair the damaged area.
- i. Unclear if spillway is adequately sized. Spillway should pass the probable maximum flood. Verify spillway capacity and take corrective action as required.
- j. clear vegetation and one tree

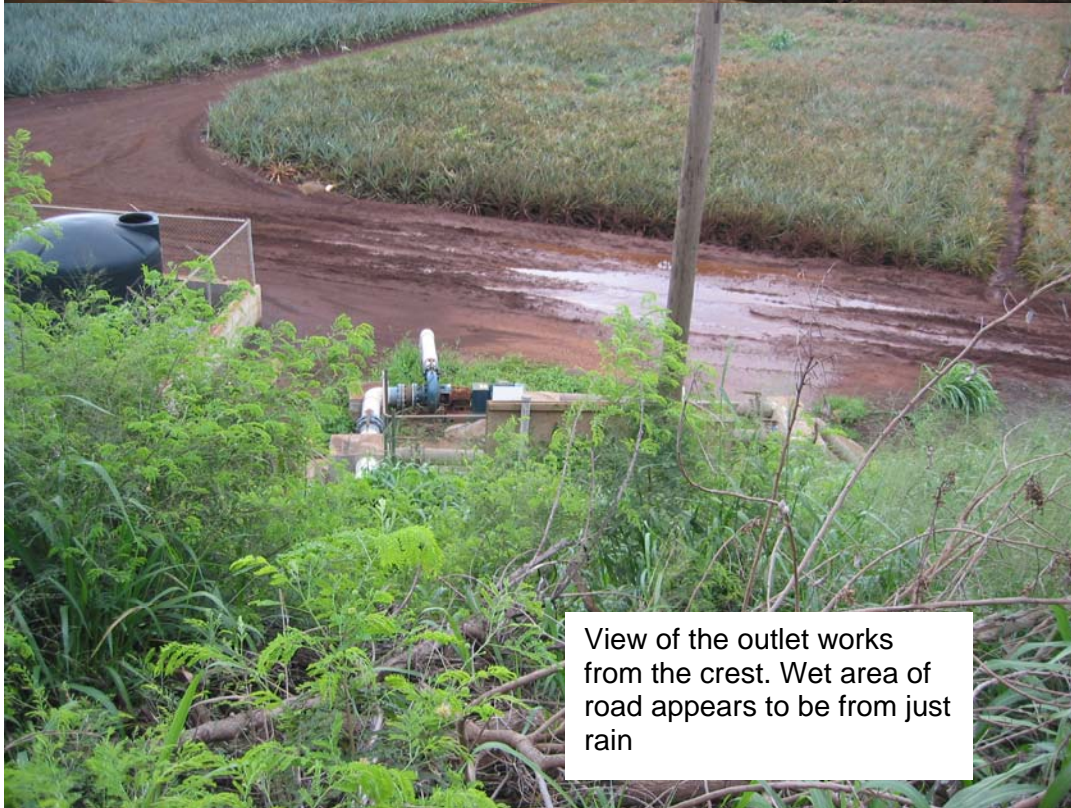
View of the outlet works from the crest. Wet area of road appears to be from just rain
